**Asia-Pacific  
Economic Cooperation**

**Lessons Learned in Upgrading and Refurbishing  
Older Coal-Fired Power Plants  
A Best Practices Guide for Developing APEC Economies**

**APEC Energy Working Group  
Expert Group on Clean Fossil Energy**

**October 2008**

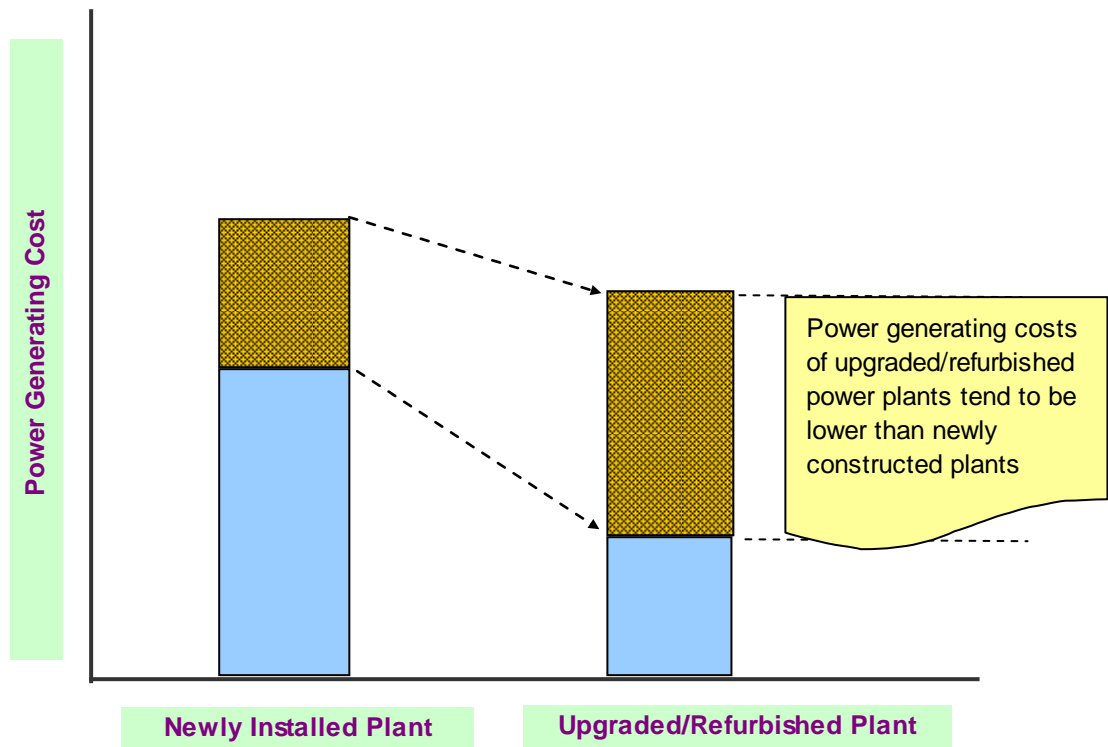
Figure 2 Comparisons of Power Generating Cost between Newly Installed and Upgraded/Refurbished Generation Units

What makes refurbishment and upgrade options more attractive is that in a number of situations the results of upgrade efforts produced more economically feasible options than if the same amount of generating capacity were obtained from newly built power plants. Shown below in Figure 2 is the likely result of a refurbishment/upgrade as compared with a newly built generation plant:

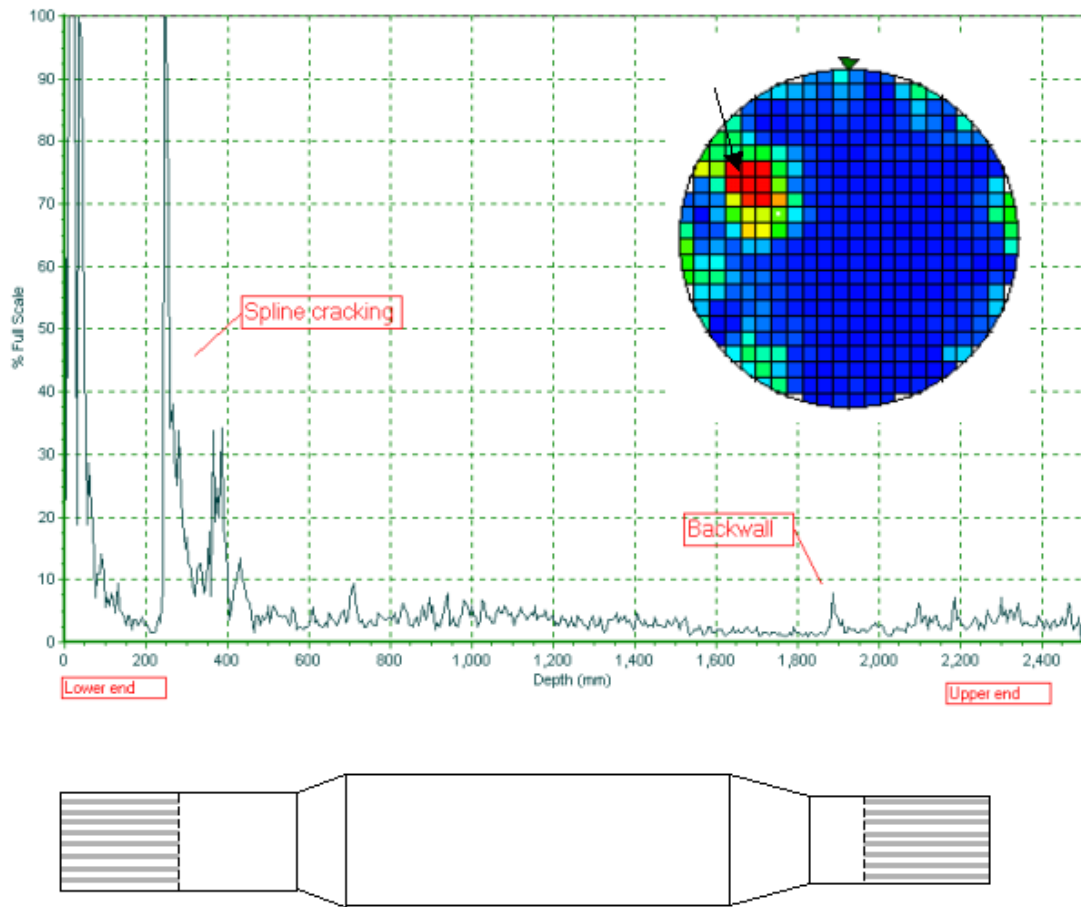
Figure 3 Ultrasonic Test of a Mechanical Part

**Ultrasonic Testing (UT)** - In ultrasonic testing, very short ultrasonic pulse-waves with center frequencies ranging from 0.1-15 MHz and occasionally up to 50 MHz are launched into materials to detect internal flaws or to characterize materials. The technique is also commonly used to determine the thickness of the test object, for example, to monitor corrosion rates in pipes. A sample of an ultrasonic test application is shown in Figure 3. Ultrasonic testing is often performed on steel and other metals and alloys, though it can also be used on concrete, wood and composites, albeit with less resolution.

Ultrasonic Testing (UT) is a Non-Destructive method to detect material flaws or early indication of failure and the procedure employs the application of sound waves having frequencies usually in the mega-hertz range. There are two basic methods in UT, namely: *pulse echo* and *through transmission*. While the former method makes use of a single transducer, the later makes use of two. In the pulse echo method a transducer, made of piezoelectric material, transmits a pulse of mechanical energy into the material. The energy passes into the material, reflects from the back surface, and is detected by the same transducer, yielding a signal on an oscilloscope with a time base. The oscilloscope normally shows the original pulse of the ultrasonic transducer (front surface echo), the back reflection and any extra blip indicating a reflection from a defect in the material. From the oscilloscope timing, the depth of the defect below the surface can be determined. Alternatively, in the transmission method, two transducers are placed on opposite sides of the material and any reduced intensity sensed by the receiving transducer indicates defect shadowing part of the ultrasonic energy. The location of defect can not be obtained. Both pulse echo reflection and transmission methods are in use and their selection depends on the accessibility of the component.

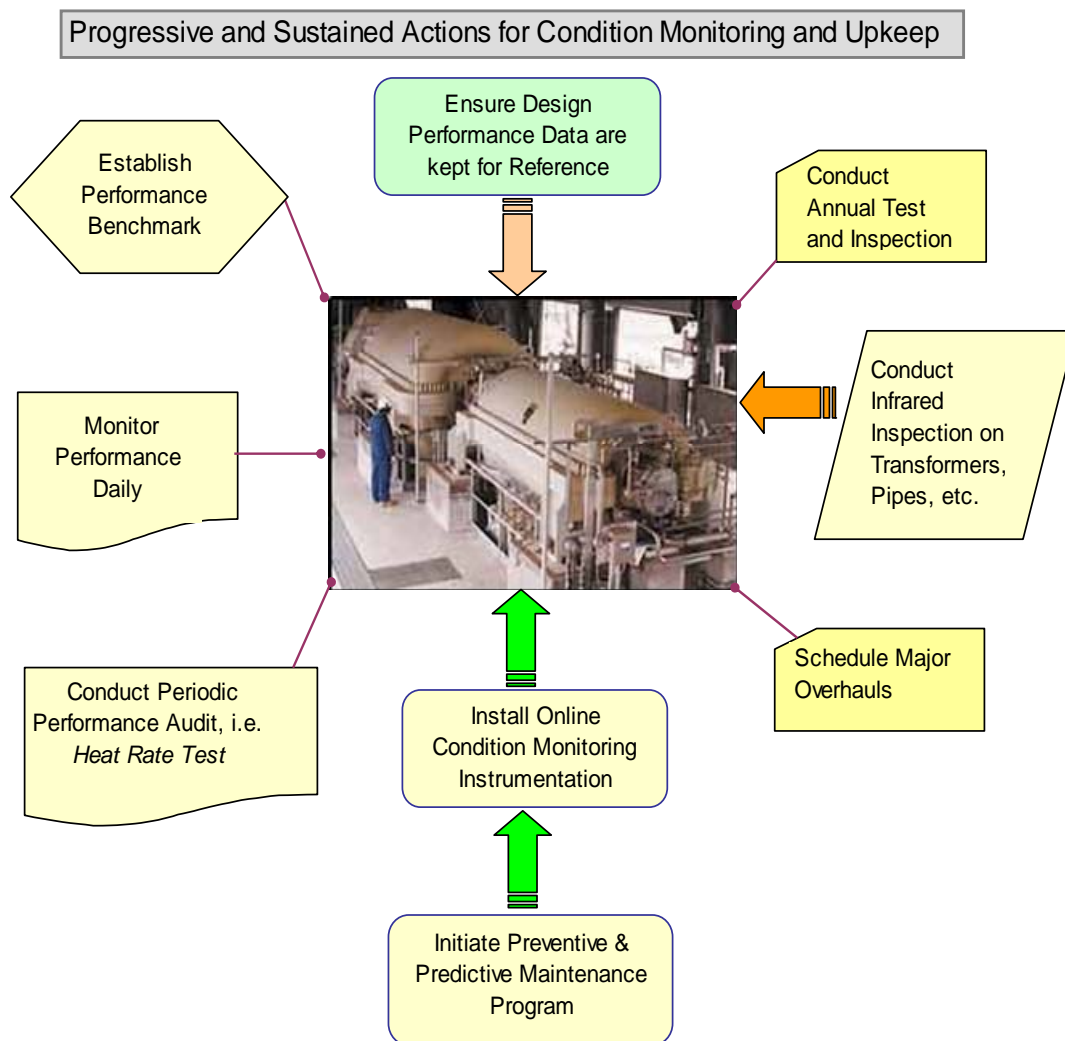
Figure 8 Monitoring Equipment Condition and Performance

Periodic performance testing, as discussed in the preceding paragraph, can be expensive. Some companies or organizations maintain their own Performance or Results Engineering groups with trained personnel capable of conducting such an extensive test. The exercise involves sophisticated instrumentation and specific time duration dedicated to each identified unit that will undergo testing. These units may be disengaged from Automatic Dispatch Systems (ADS) mode. This exercise may also involve a select group of operating plant staff/personnel to witness such a test. It is, therefore, incumbent upon management to determine the optimum frequency of testing within a given year. One good method of justifying a less frequent performance testing schedule is to follow a strict performance trending and condition monitoring program to compensate for a longer gap between extensive performance tests. The following diagram illustrates the basic items covered in a continuous condition monitoring program and performance trending set-up in a power plant:

There will be fewer surprises to plant operators if performance trending and monitoring programs are strictly followed. Modern Data Acquisition Systems (DAS) functions are integrated and incorporated into Distributed and Control Systems (DCS) functions and have now reached a stage of sophistication where practically all critical operating parameters are automatically monitored, and major plant equipment is fully outfitted with adequate permissive, interlocks, alarms and tripping

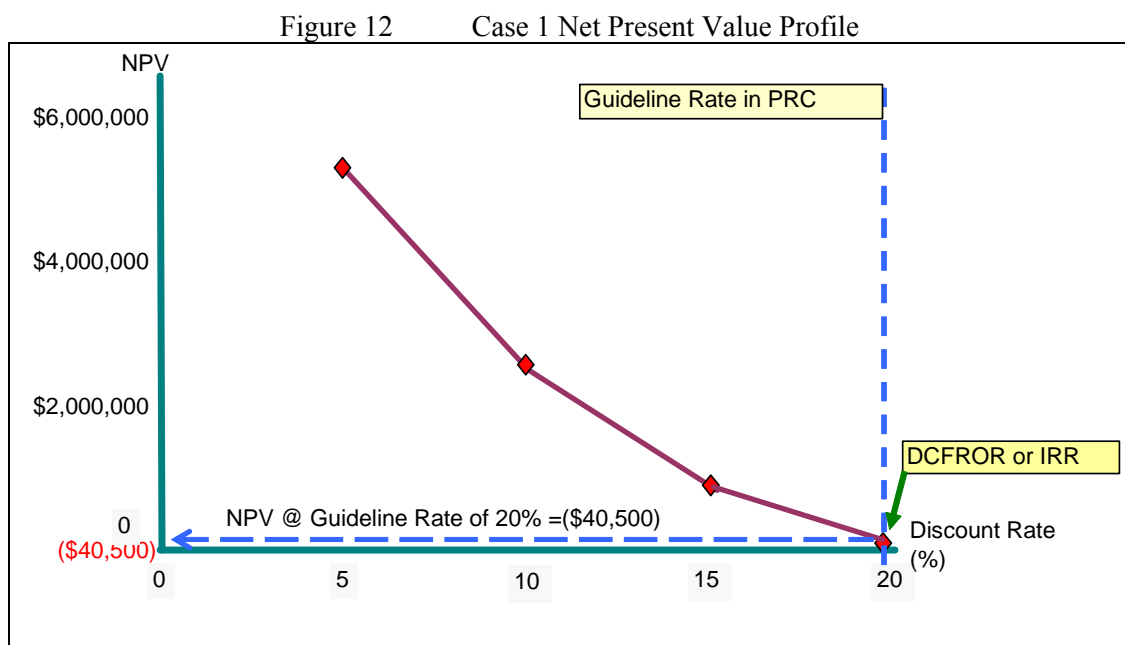
The result of this evaluation should be noted, where it revealed that as contrasted to a prevailing return to investment in the Chinese market of 20% of self-generated capital, the project return projection was short of \$40,500 to match an opportunity investment somewhere else which could have yielded 20%. This being said, there are other intangible aspects of the project which are not readily quantified, such as reduced pollution, improved reliability, etc. which could not be gained by the plant if the funds were not used for these upgrades.

The Net Present Value Profile for the project is shown in Figure 12.

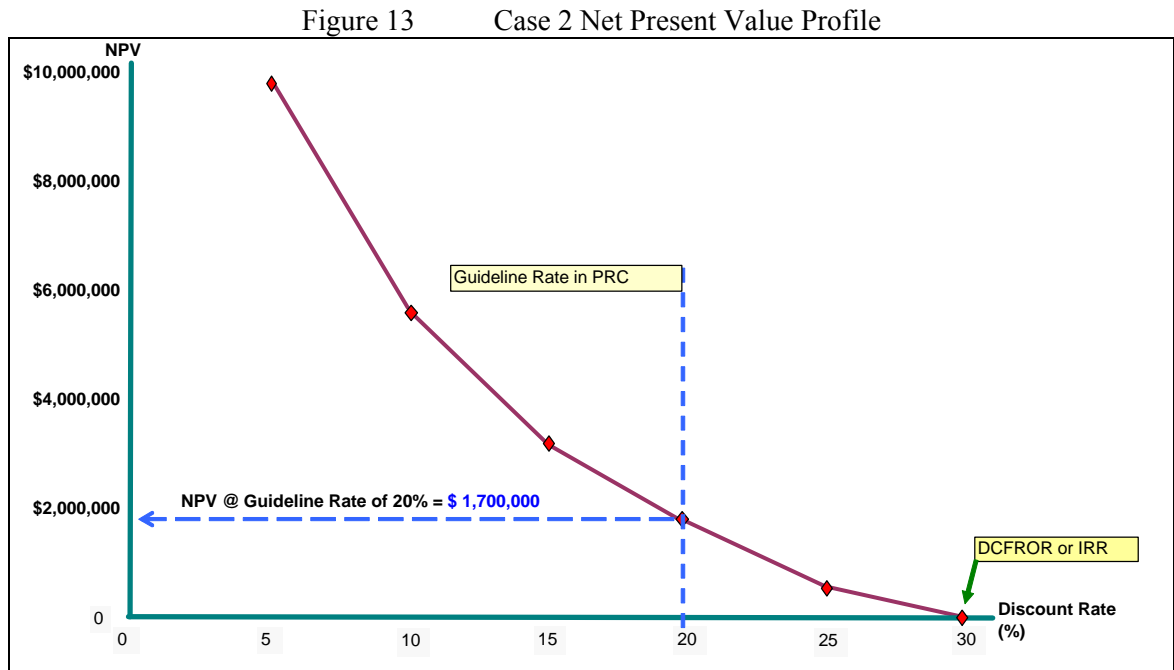
- Discounted Cash Flow Rate of Return (DCFROR) = 29.54%
- NPV @ 20% Guideline Rate (Base Year 2004) = \$1,700,000
- Payback Period = 3.74 years

The Net Present Value Profile for the project is shown below.

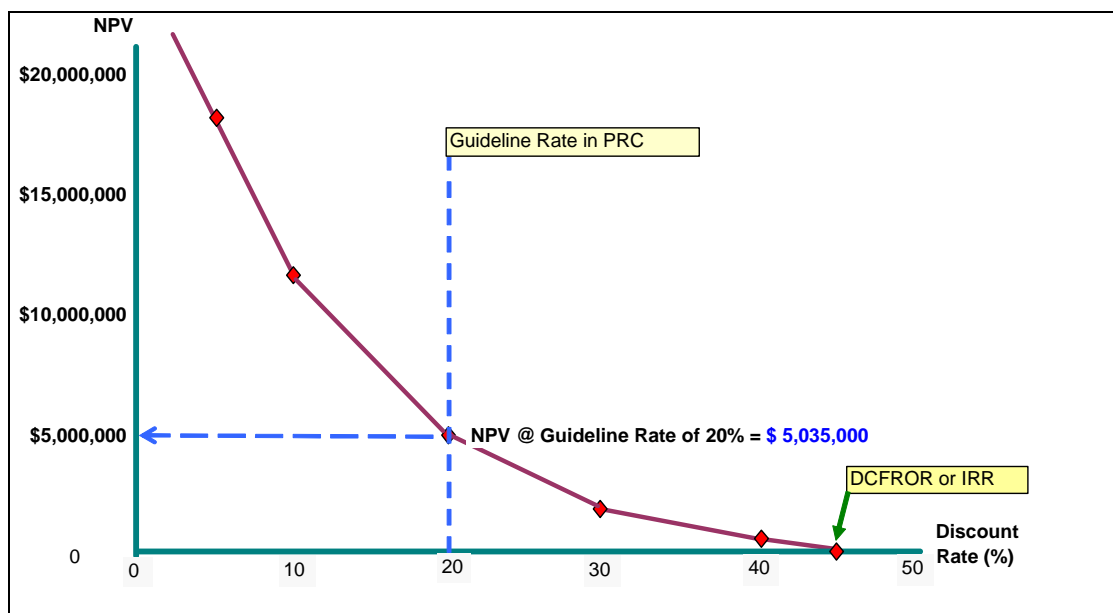
Figure 14 Case 3 Net Present Value Profile

The Net Present Value Profile for the project is shown below.

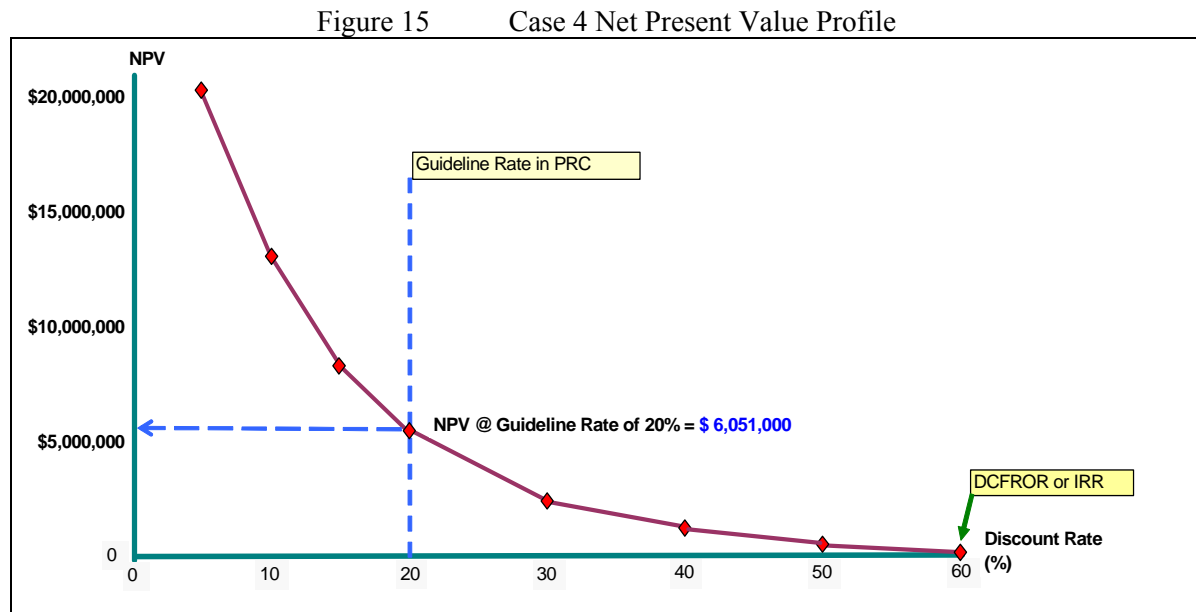
*Note:* This power plant has been in commercial operation since the 1980s. The refurbishment, after a period of steady decline on performance, had definitely given a substantial improvement on the plant heat rate. On the other hand, the cost of refurbishment was not as high as those of the other plants; hence, the higher rate of return on this particular project investment. Net present Value of investment is obviously high given that the plant has been given a second lease of life with a relatively low capital infusion.

The Net Present Value Profile for the project is shown in Figure 15.

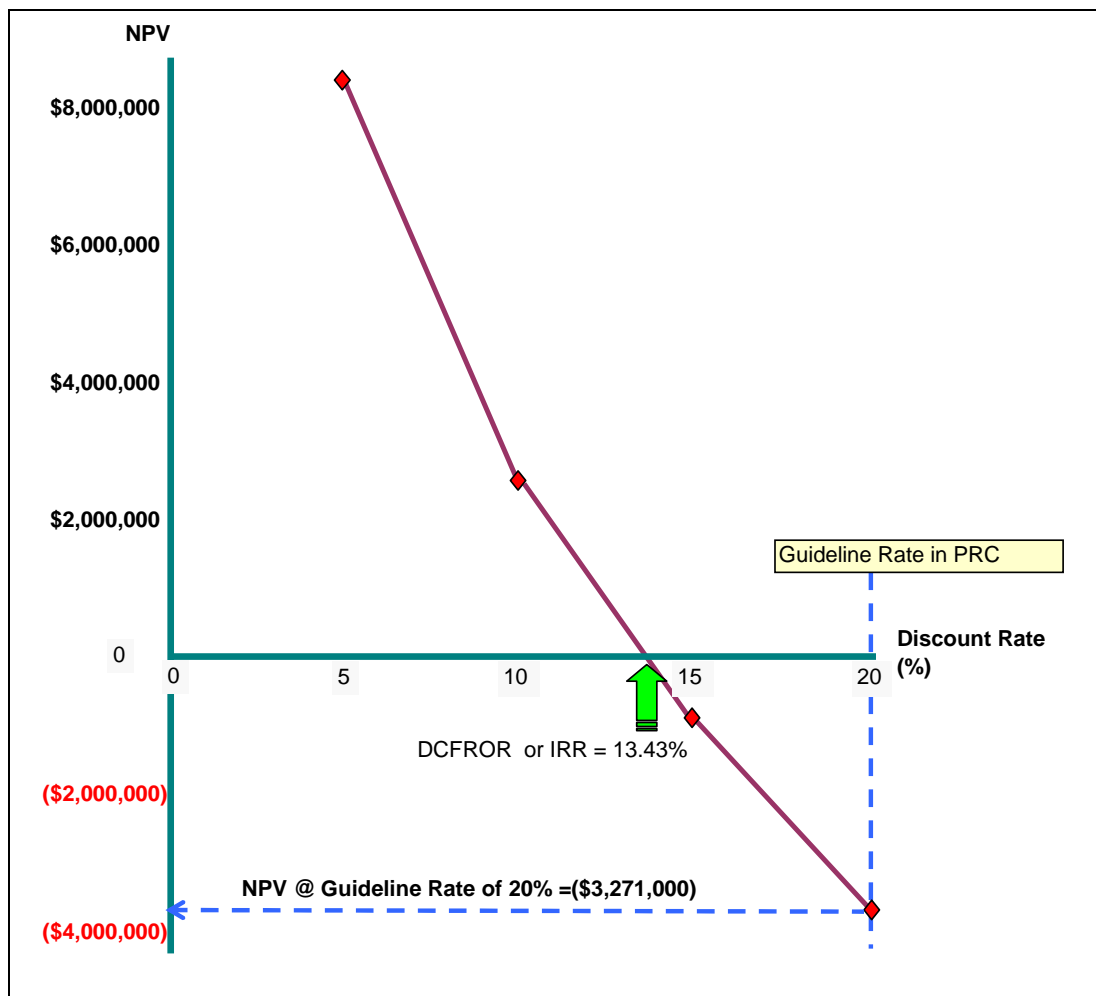
Figure 16 Case 5 Net Present Value Profile

The Net Present Value Profile for the project is shown in Figure 16.
